BEAVER POND DAM

NDI I.D. NO. PA-00408

PHASE I INSPECTION REPORT
NATIONAL DAM INSPECTION PROGRAM.

Beaver Pond Dam (NDI I.D. NO. PA-00408)
PENNDER I.D. NO. 52-13) Delaware River

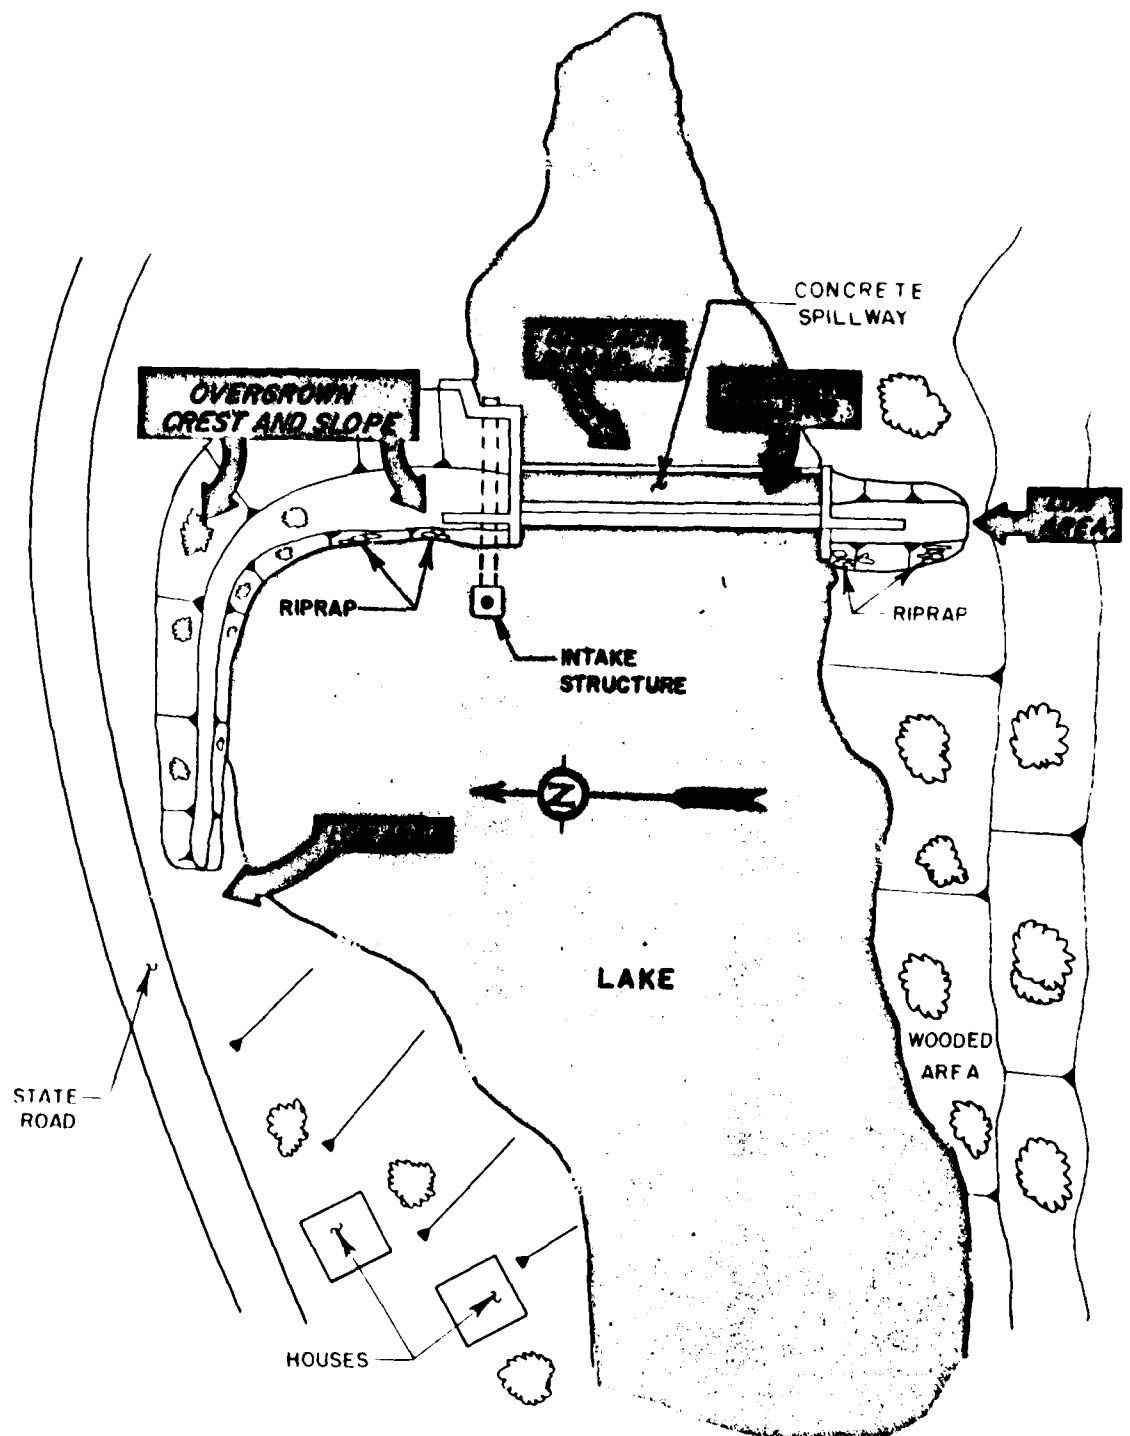
BEAVER POND DAM
GENERAL PLAN-FIELD INSPECTION NOTES

1. Low areas approximately one-foot below the design crest elevation occur in both the left and right abutments. An accurate survey is recommended and the areas should be regraded consistent with the design top of dam elevation.
